NATIONAL PROGRAM FOR INSPECTION OF NON-FEDERAL DAMS
GALE MEADOWS DAM (VT (U) CORPS OF ENGINEERS WALTHAM MA
NEW ENGLAND DIV MAR 80

GAIA MEADOWS DAM VT 00115

MAR 1980

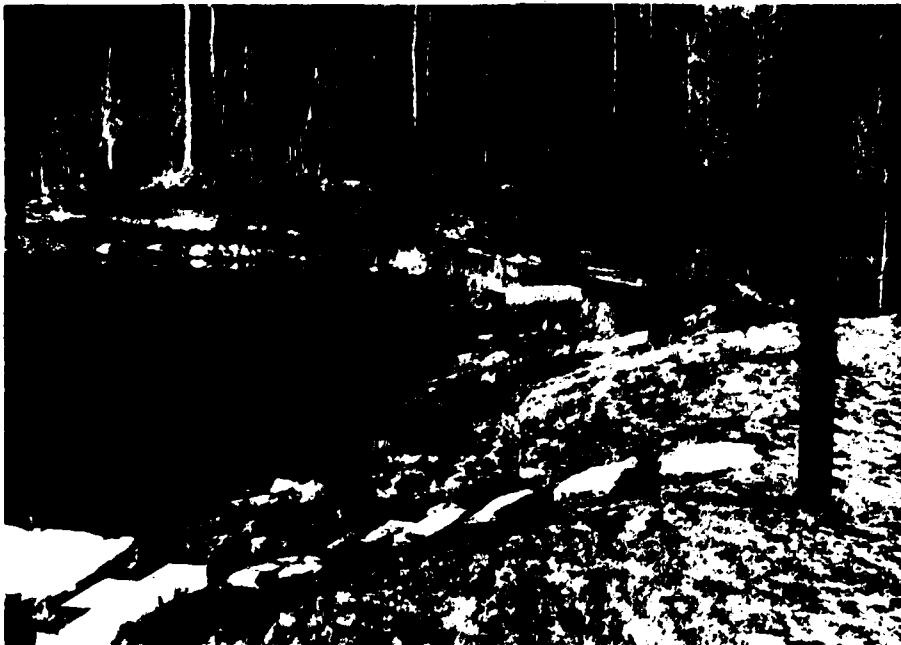
C-2B Upstream face of dam looking toward left abutment .
Note emergency spillway weir in right background .
11/19/79

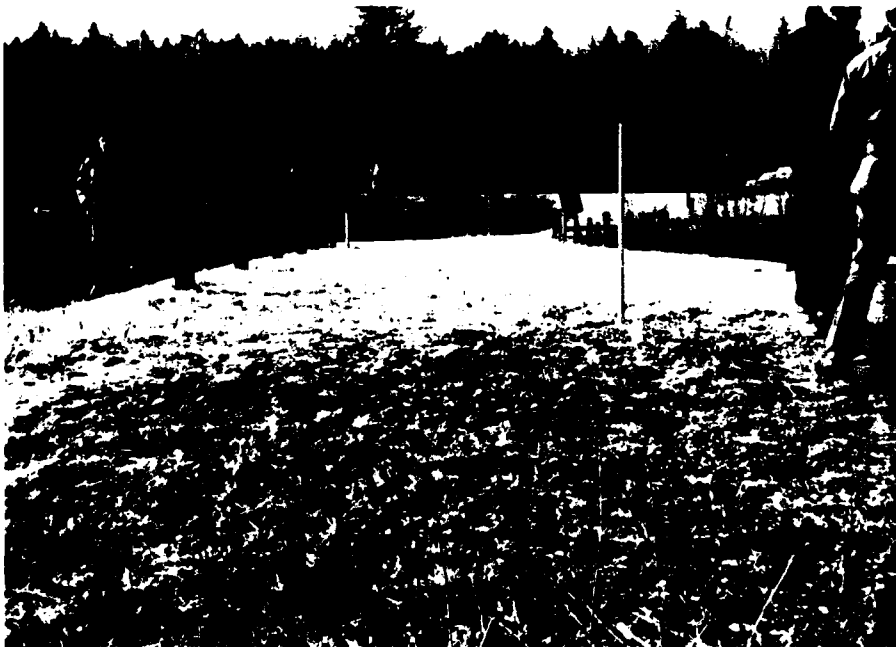
C-3B Dam crest looking toward right abutment - 11/19/79

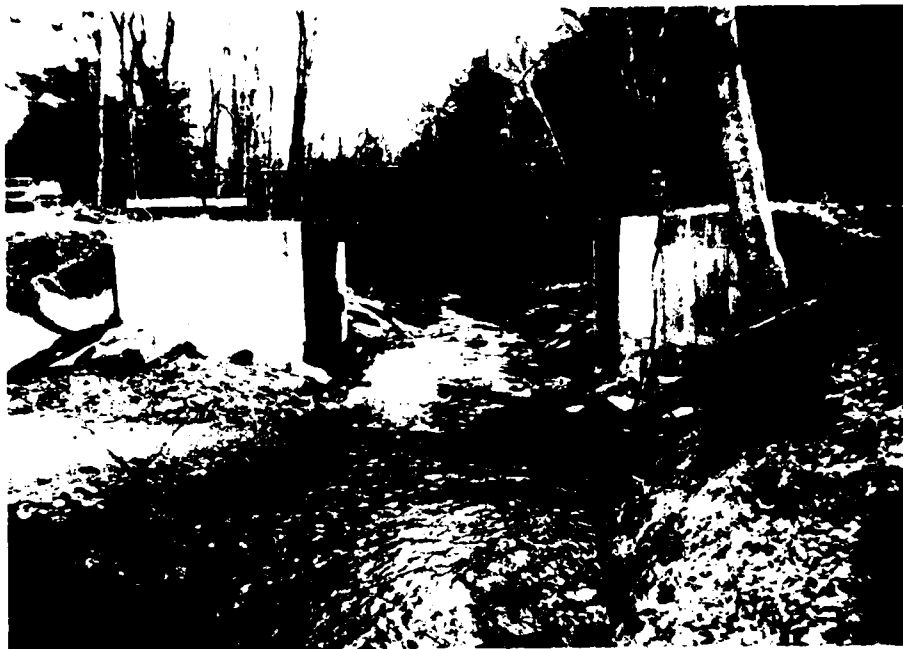
C-12A Bridge over Mill Brook about 1000 feet downstream from dam,
looking downstream - 11/19/79

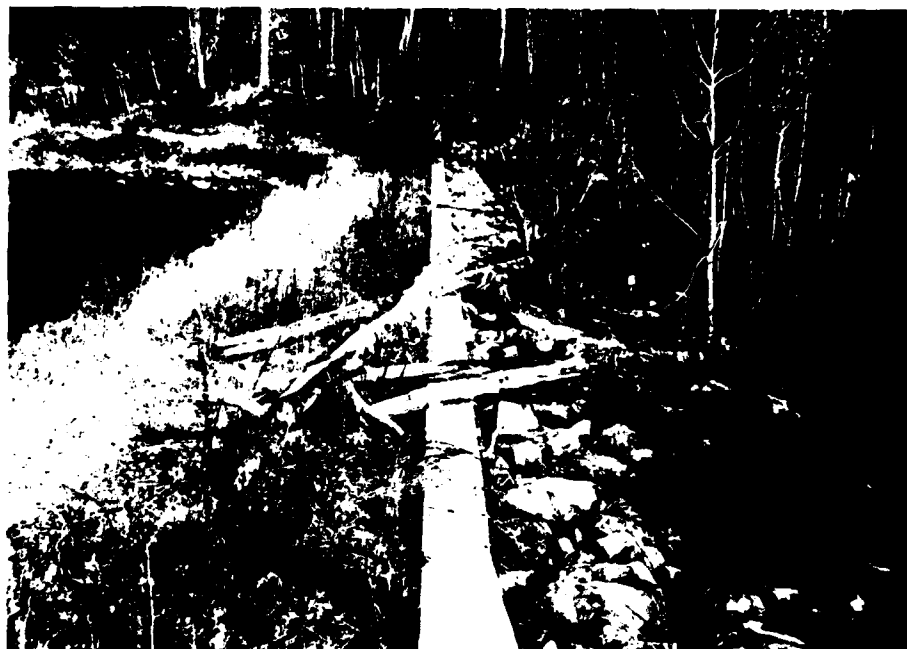
C-9A Emergency spillway weir control section looking toward left abutment - 11/19/79

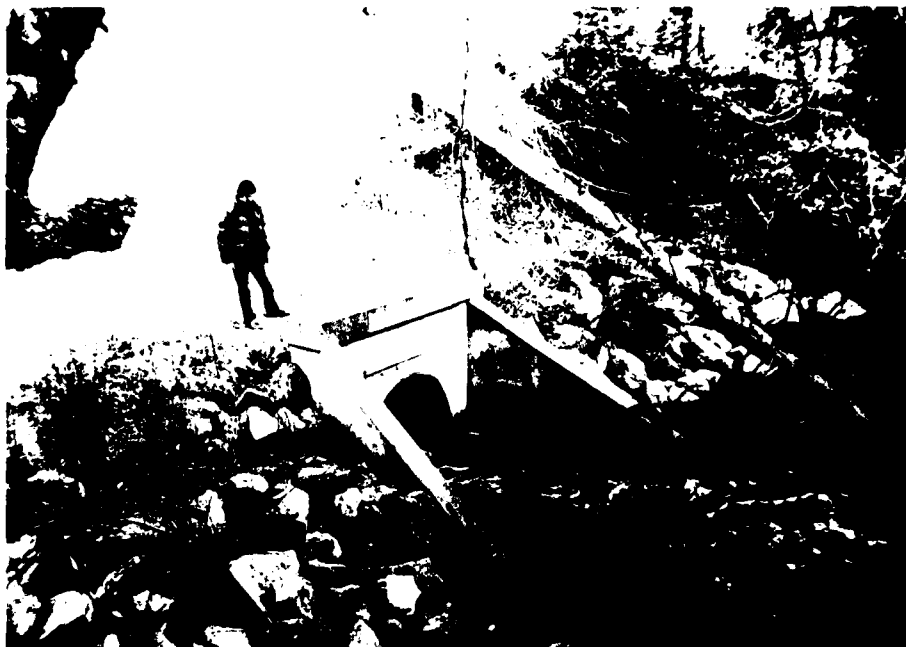
C-8A Service spillway outlet structure - 11/19/79

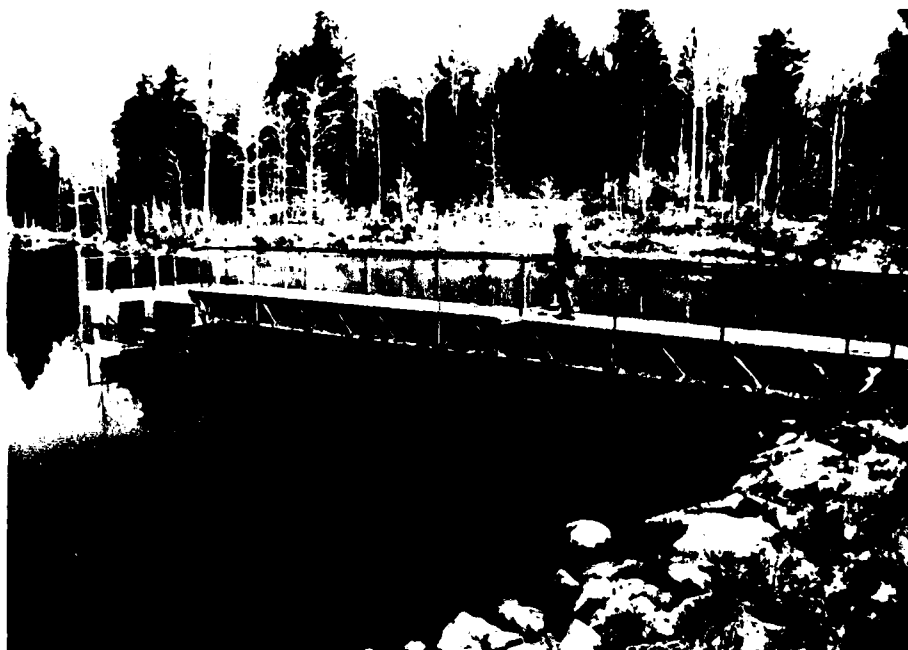
C-7A Drop inlet service spillway structure and service bridge
looking from dam crest - 11/19/79
